Glass container defects Causes and remedies

Table of Contents

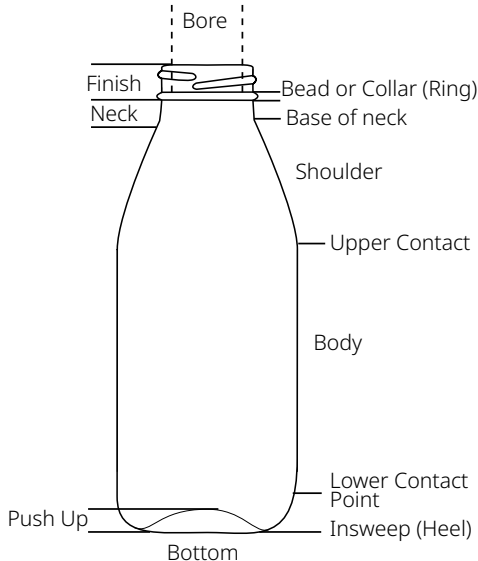
Finish This is the top of the container above the neck ring parting line.

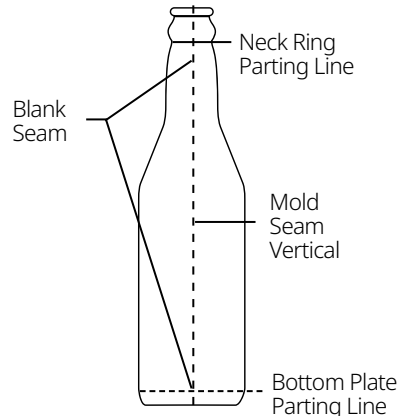
Bottom plate parting line Where the blow mold and bottom plate join there is a seam.

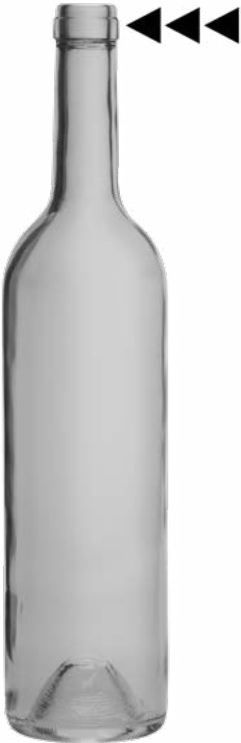
Bent or Crooked Finish

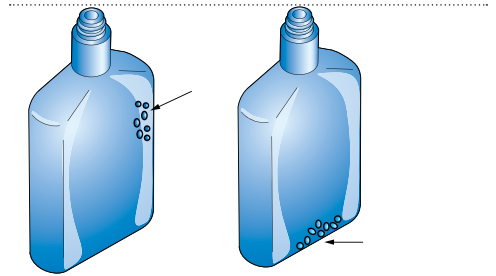
1. Furnace pull is too high
2. Furnace temperatures too low
3. Glass composition out of control
4. The atmosphere in the rear of the furnace contains carbon monoxide (CO)

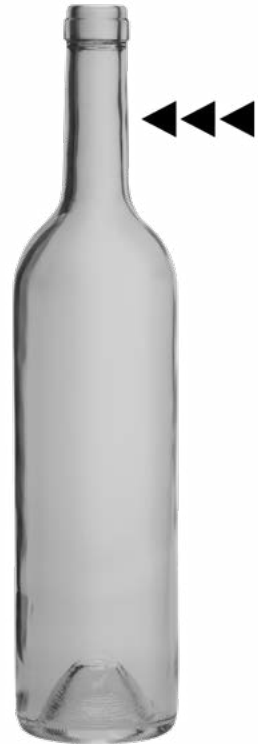
Section 2 Neck Defects

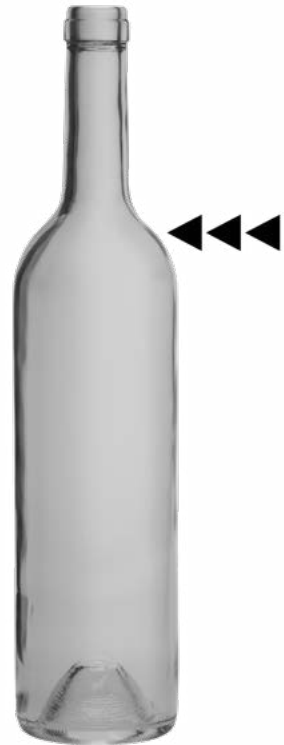
Shoulder Checks or Tears

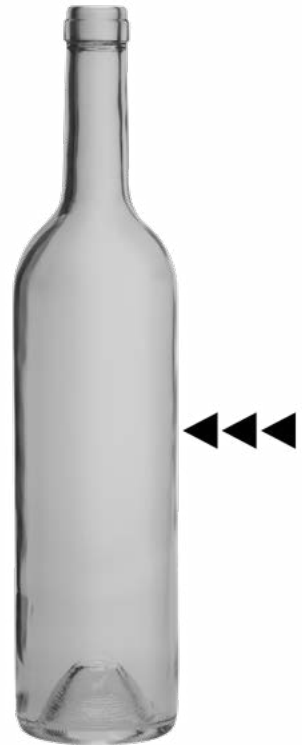
Bird Cage or Bird Swing

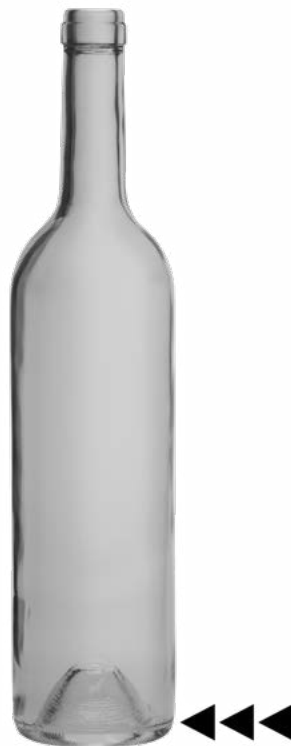
Section 5 Base and Bottom Defects
