Technical News Bulletin

Steinhausen, April 2010

FlexPusher Improved Robustness

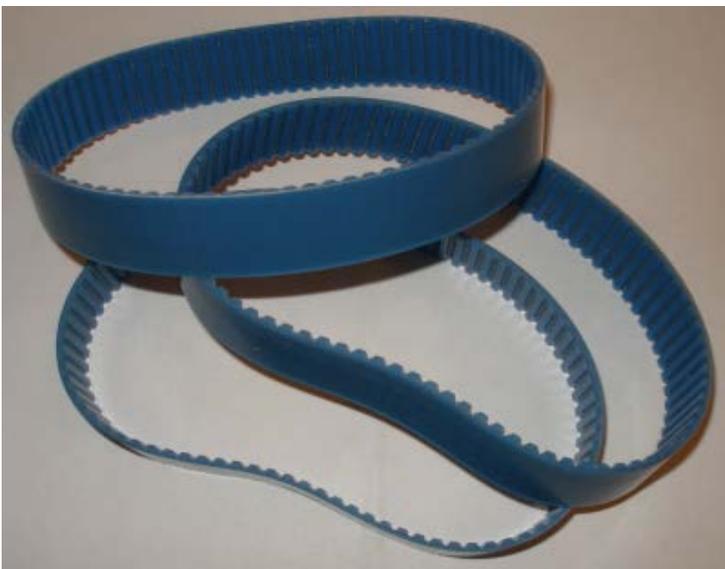
This issue has been addressed as follows: A new High Temperature Belt 59-90491, has been designed and after testing in the field, introduced as standard.
